Completion Report for

Kitchen Hood & Exhaust System Cleaning & Degreasing

Date: **12 November 2019**
Client Name: **CAPITAL MOTION**
Contact Person: **Diana Stegarescu**
Designation: **Restaurant Manager**
Site Detail: **Pacifico Tiki Lounge & Dining, Al
Bandar, Abu Dhabi.**

KITCHEN EXHAUST SYSTEM - AFTER SERVICE REPORT

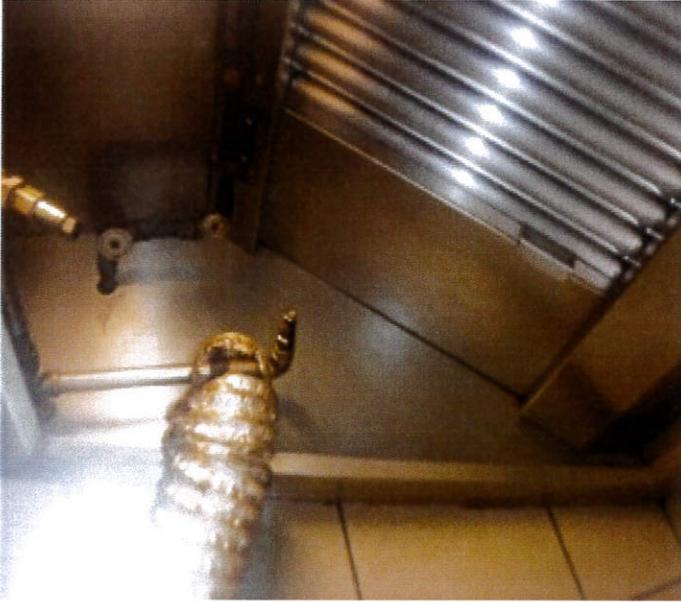
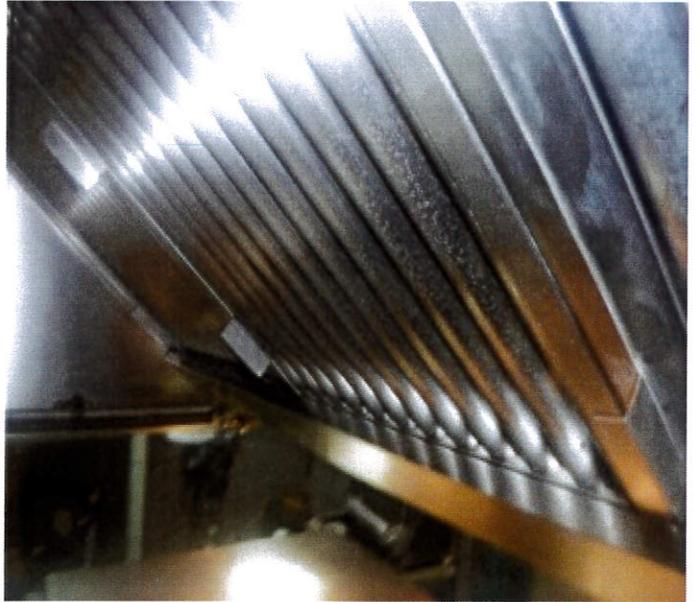
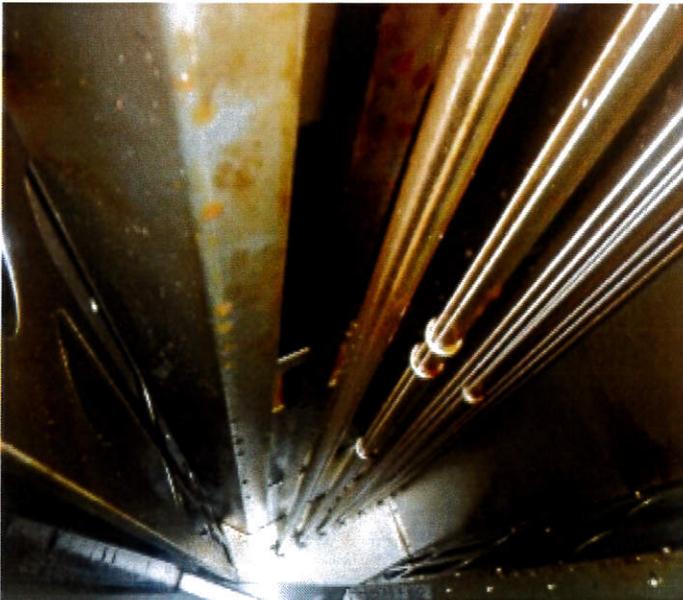
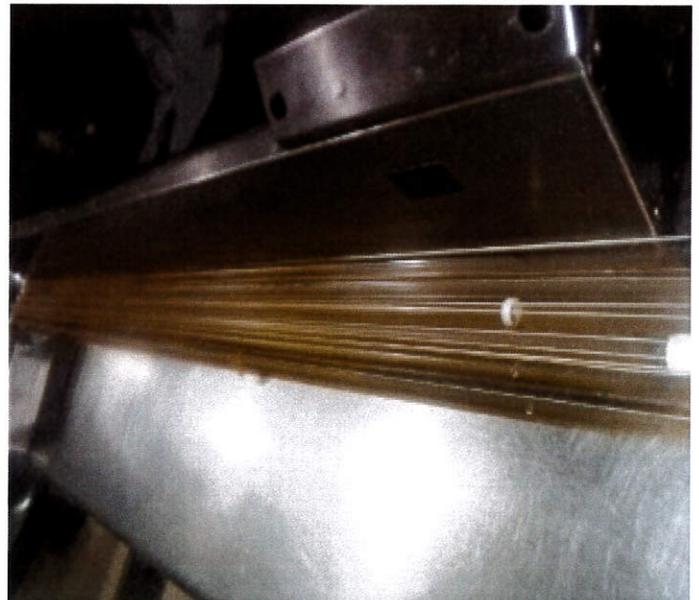
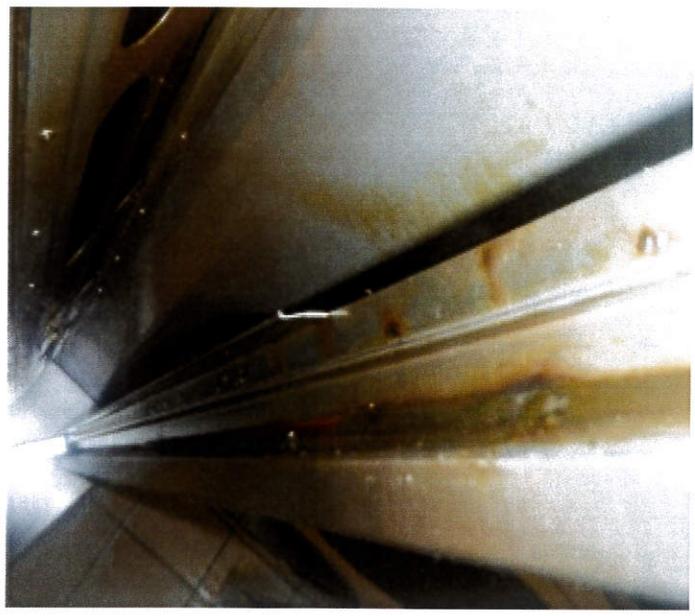
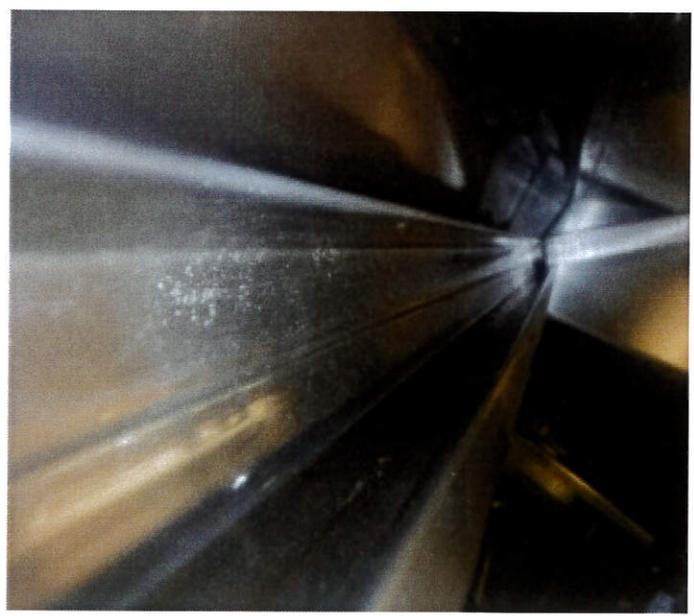
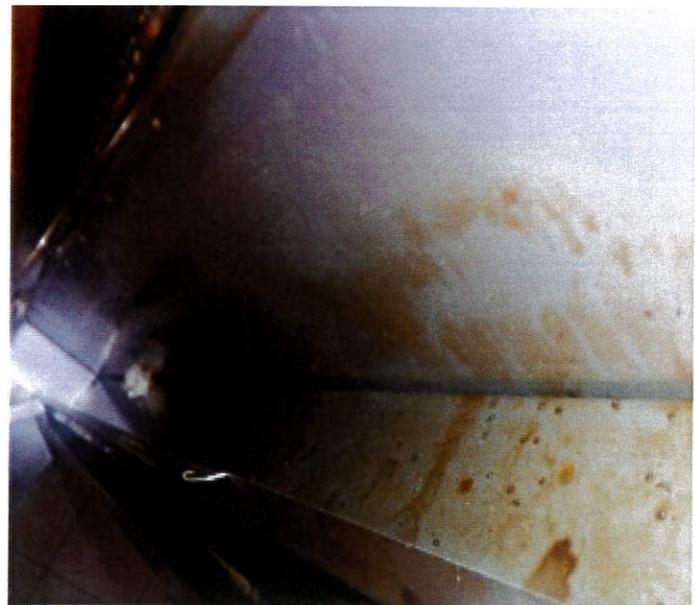
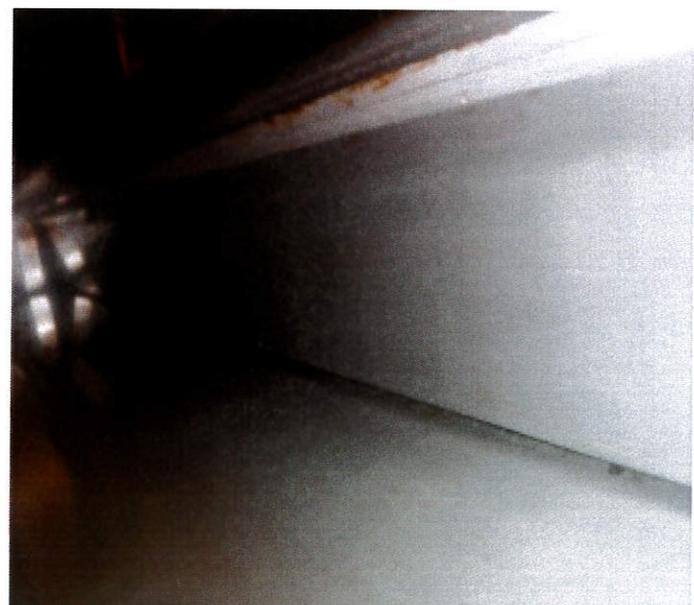
Kitchen Hood Cleaning- Tiki Kitchen

Comments: PLEASE NOTE! HOOD INSIDE UV LIGHTS NOT WORKING & THE EXAHUST FAN SWITCH CONTROL NEED TO KITCHEN INSIDE YOUR EXAHUST FAN CONTROL ROOF HAVE.

COMMENTS AND RECOMMENDATION:
ONE HOOD CLEANING & DISINFECTION COMPLETED. & DUCT CLEANING, SANITIZING AND ESP SYSTEM CLEANED. 3 NOS MESS FILTER CLEANED.

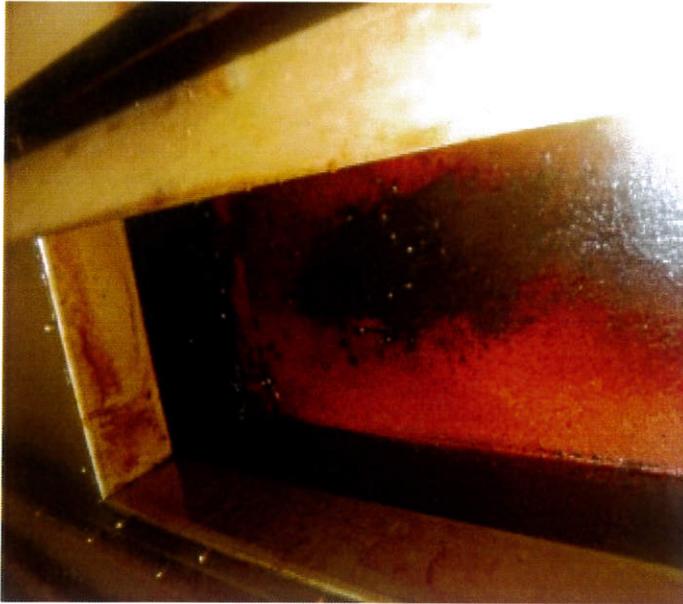
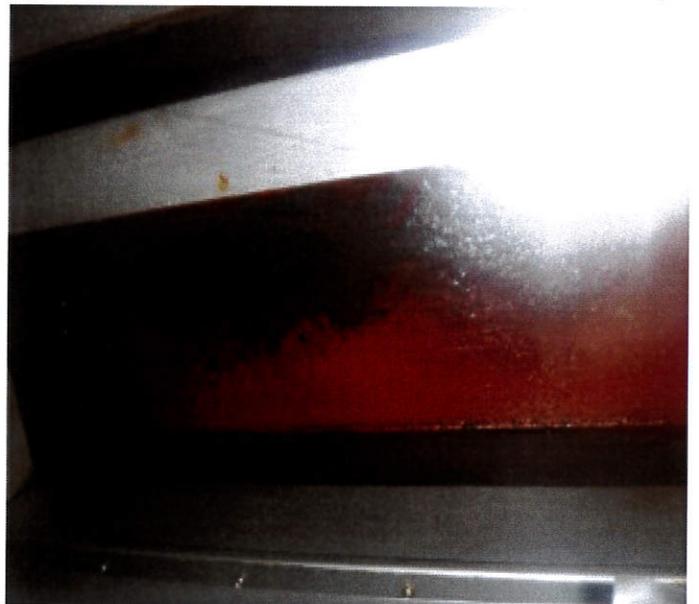
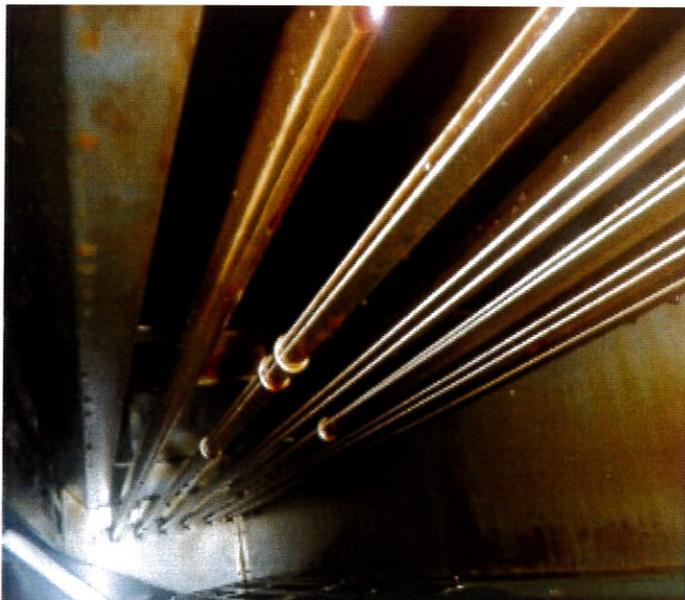
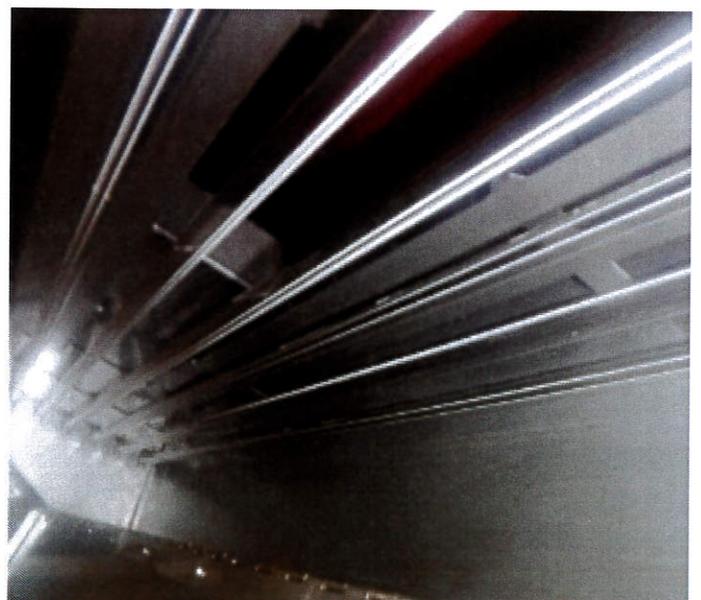
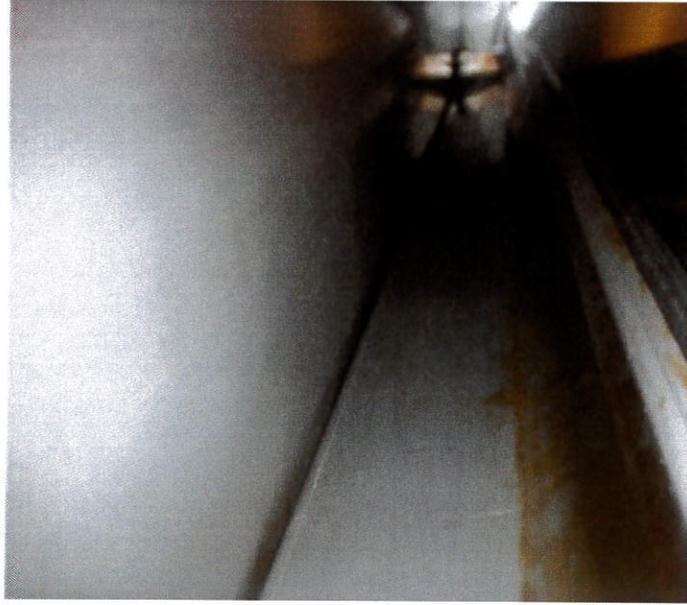
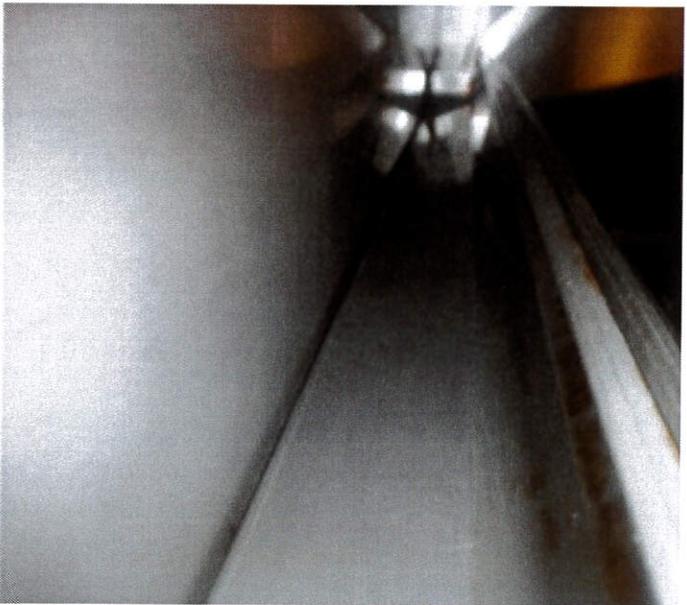
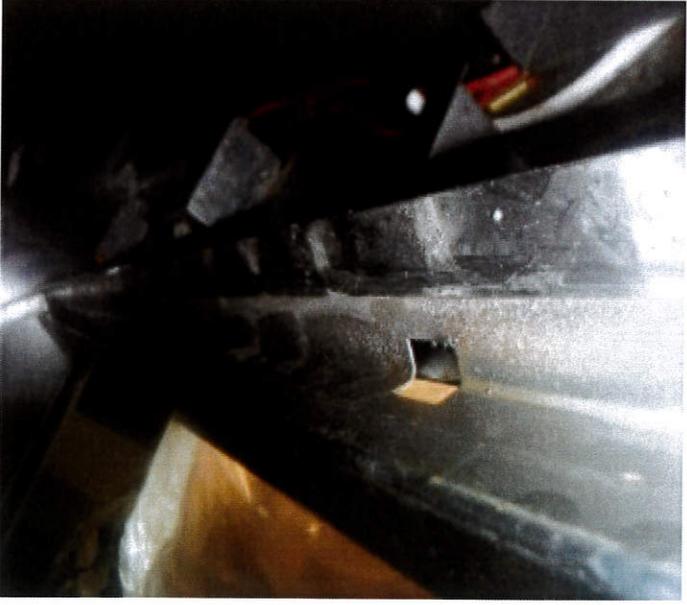
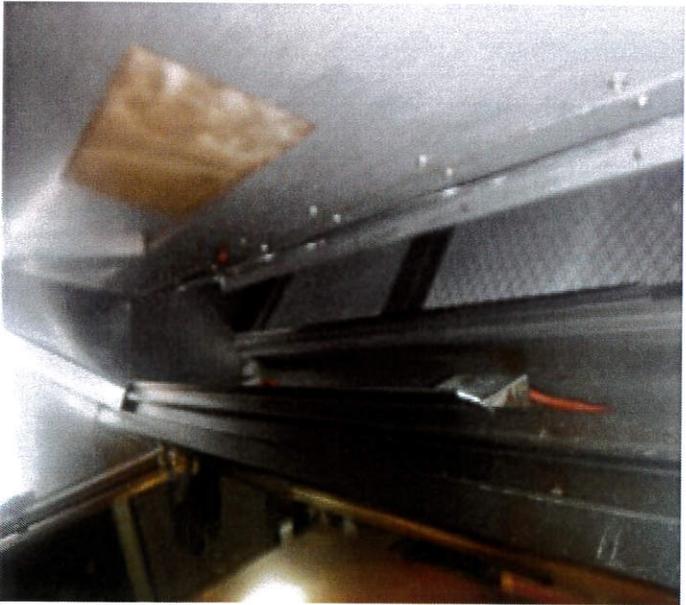
Kitchen Hood Cleaning- Ornina Kitchen

Comments: <u>ALL HOODS INSIDE VX LIGHTS NOT WORKING</u>

COMMENTS AND RECOMMENDATION: 2 NOS KITCHEN HOODS CLEANED HORIZONTAL & VERTICAL DUCT CLEANED. ALL FILTERS CLEANED.
