SEWAGE SUMP PIT TANK & GREASE TRAP CLEANING

COMPLETION REPORT

Client : EMRILL FACILITY MGT.
Contact Person: Mr. Sulfikkar A. Salam
Asst. Manager - Facilities
Site Details : The Wave Tower, Abu Dhabi
Date : 15 January 2019

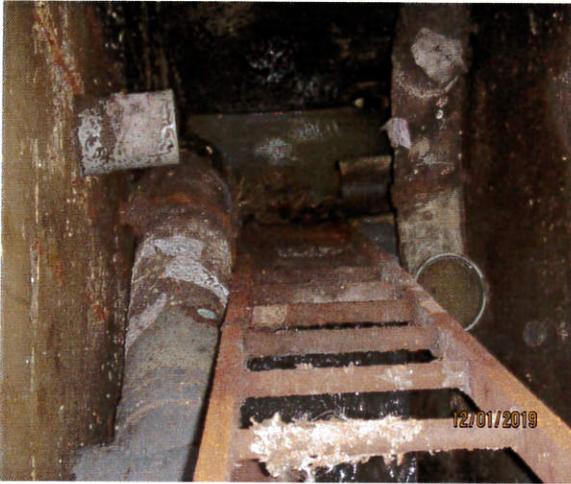
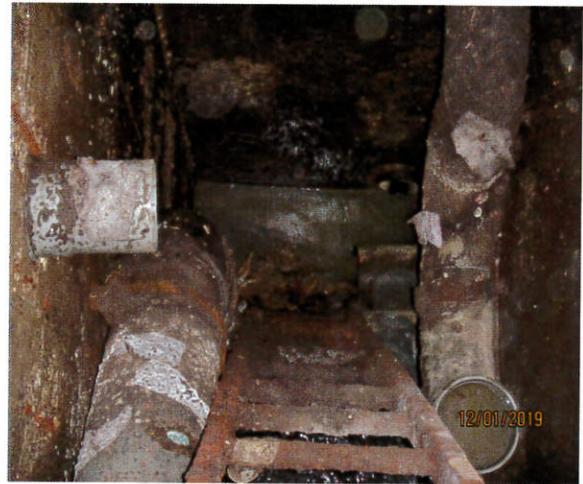
BEFORE CLEANING

COMMENTS: We found the pieces of tissues inside the grease trap.

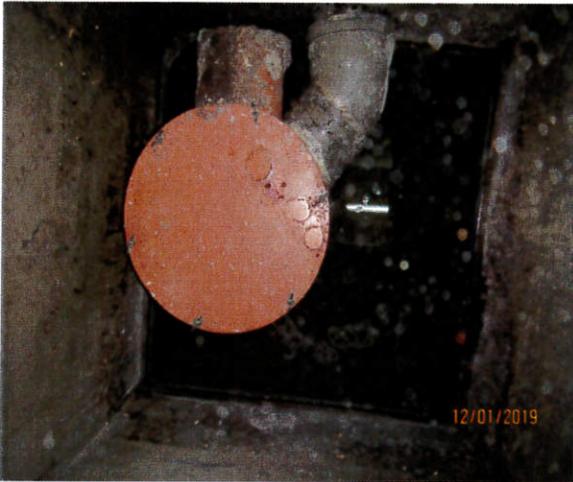
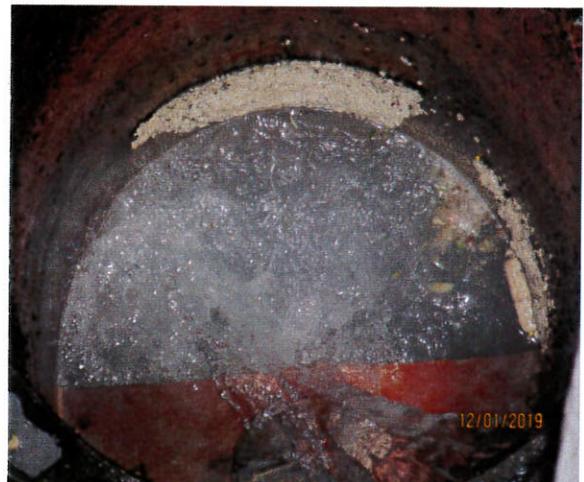
BEFORE CLEANING

We found some tissues inside the grease trap.

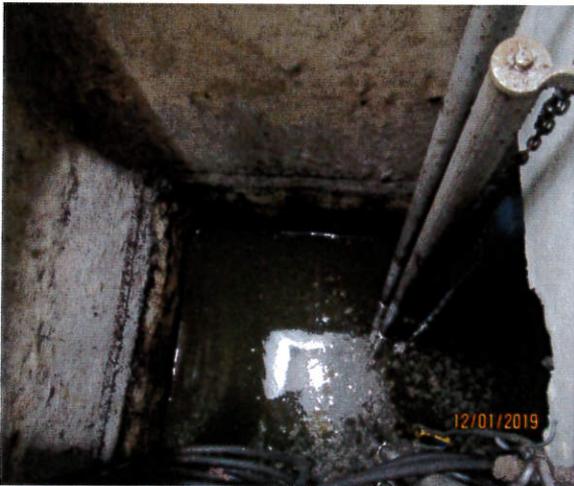
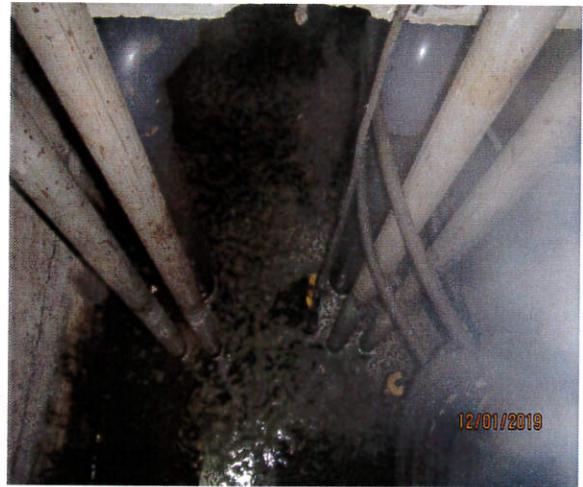
BEFORE CLEANING

COMMENTS: the Pipe of the pump No 01 it's either crack or screwed incorrectly. it rejects the water.

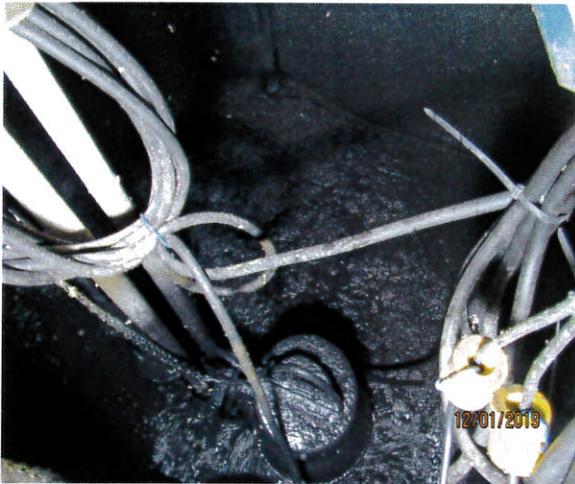
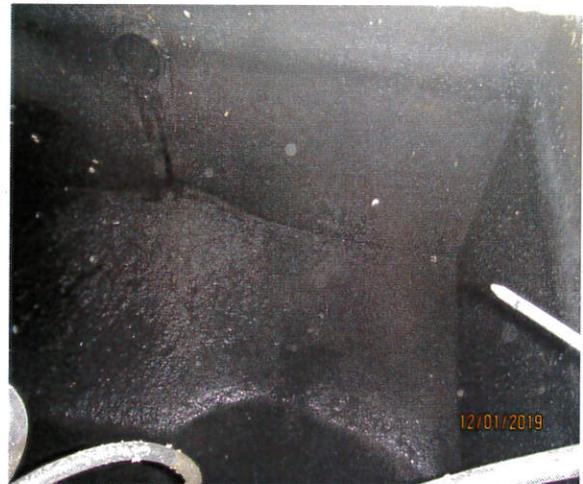
BEFORE CLEANING

Very dirty.
